**BOOM ARM MOWER**

# **INFORMATION & SERVICE BULLETINS**

Manual P/N 02980501  
(08/05)

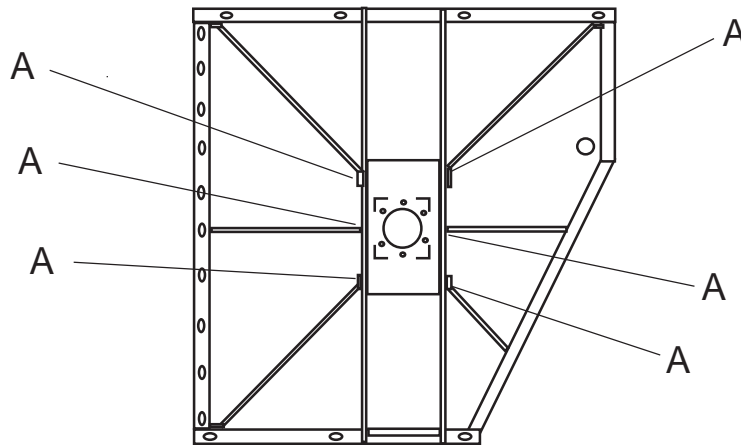
If cracks appear in the welds at points "A" as shown above, use the following procedures to repair head.

1. Grind a groove at the site of the crack and clean the area to be welded.
2. Weld the crack making a 100% weld.
3. After repairing the cracks, prepare the sites for installation of the gussets.
4. Position the reinforcing bar gusset part no. 02970111 if 90° or part no. 02970112 if 48° over the X-Bar as shown in drawing next page. Weld with a 1/4" fillet weld on the bottom and an edge weld on top. DO NOT weld the ends.
5. Clean and paint the area.
6. Reassemble any parts that were removed.

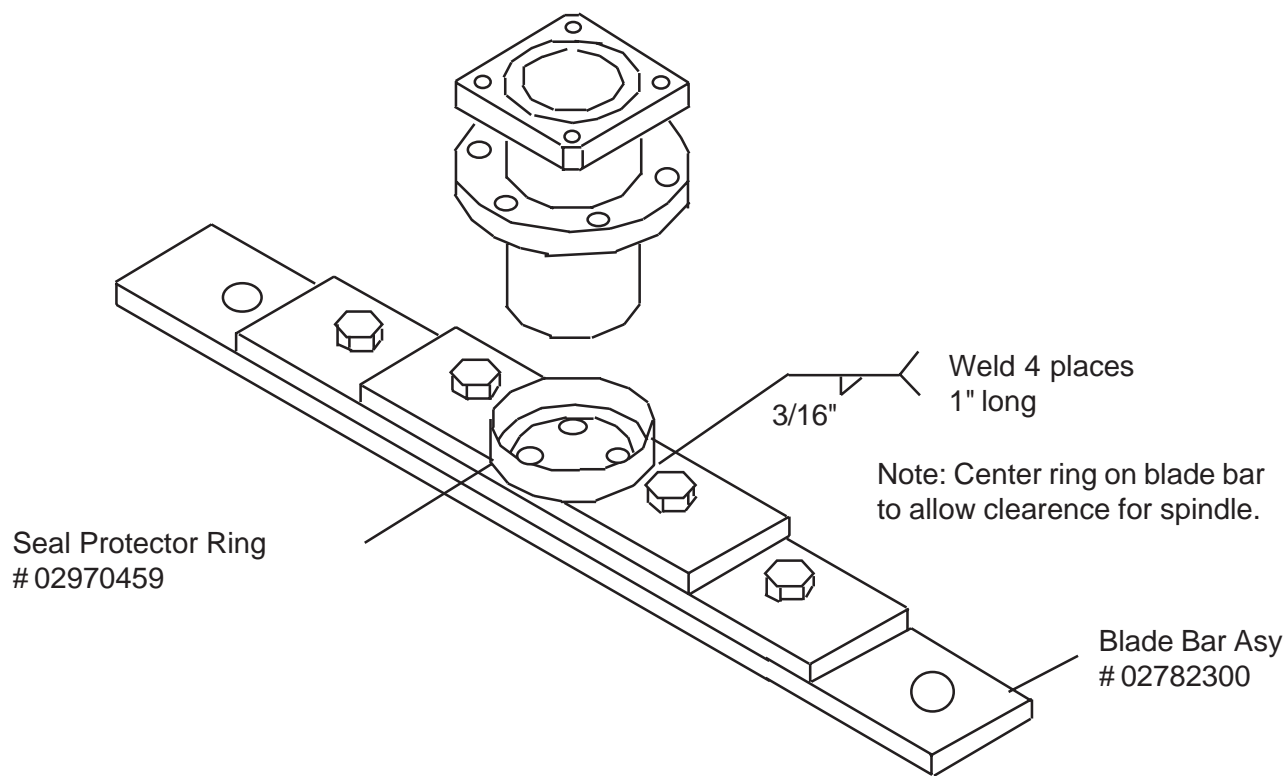
A few machines have experienced operational problems such as failure of the blade bar to rotate when the mower is engaged or a slight loss of power at the blades. Sometimes it is assumed that the spindle has seized and the spindle is replaced without investigating further.

The problem is usually found to be that the spindle end cap cover is binding on the spindle housing, creating sufficient drag on the shaft to result in the symptoms described above. This condition is a result of material (Vines, Wire, etc.) wrapping around the cover and forcing it to contact and drag against the spindle housing, causing no damage to internal components of the spindle.

The new seal protector will have to be welded to the upper blade bar as shown on the next page and the old seal protector which is on the spindle will be discarded. Make sure that the Blade bar retaining bolts are properly torqued when reattaching to spindle and that components are good condition.

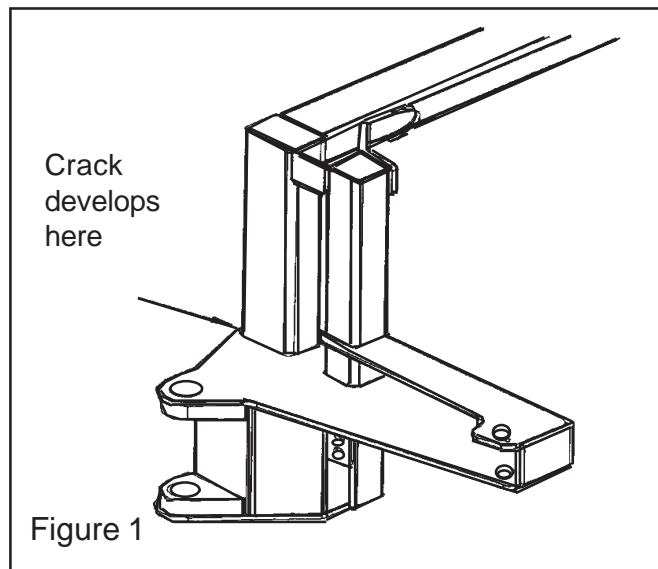
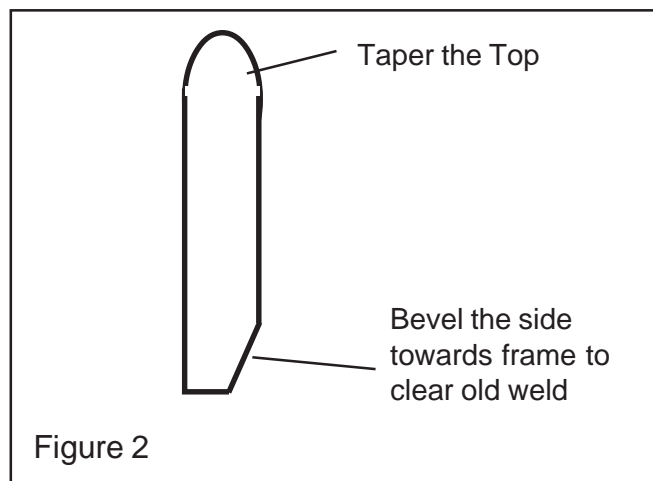
There have been some cracks in the main frame of some machete mowers

If a crack should develop (See Figure 1), use the following procedure to make repairs until a permanent repair is developed. NOTE: This repair will allow the machine to continue operating while a long term correction for the problem is being developed.

1. Grind out old weld (crack) and weld the crack, Do not use an excessive high repair weld as you will need to grind repair weld down smooth.
2. Prepare a piece of 1/2" X 6" HRFB cut to length (See Figure 2). The bottom should rest against the King Post frame and the top should be within 2" of the top of the frame, this will determine the height of the repair plate (See Figure 3). Bevel the bottom side of the plate that is towards the frame to allow for the old weld. This will be evident if you test fit the repair plate.
3. Place the stiffener repair plate against the vertical member of frame (as shown in figure 3) and tack weld into position, Make sure repair plate is flat against the frame.

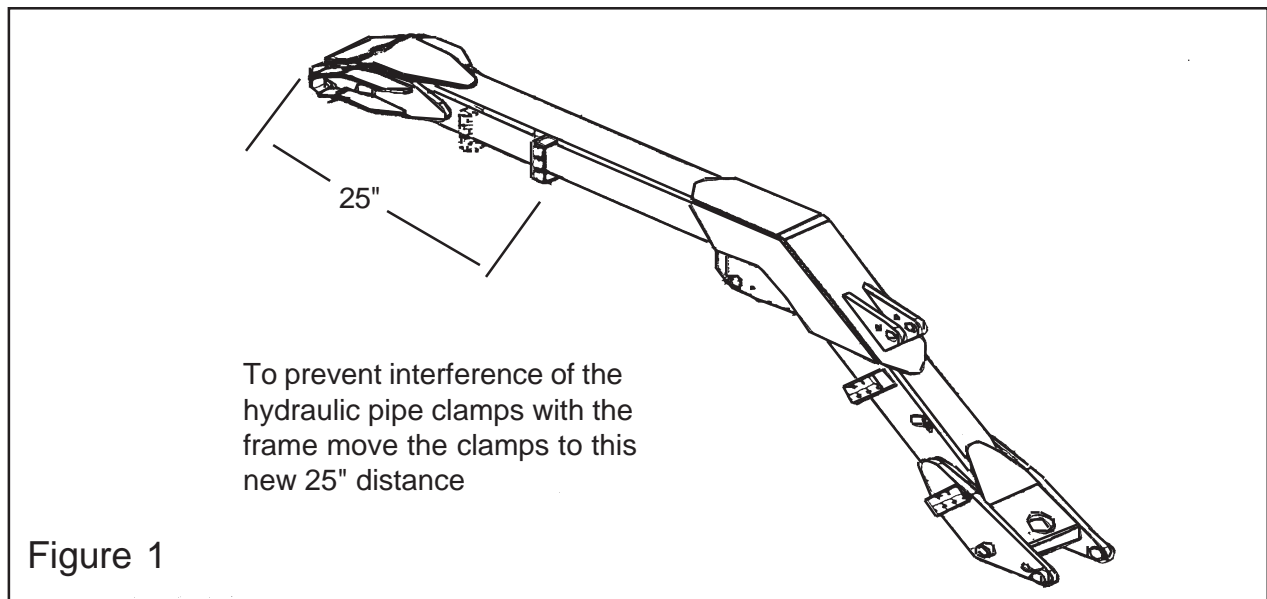
Figure 1

It is possible that the boom hydraulic tube clamps may contact the main frame when boom is raised to its highest position. This condition effects only machines with certain frames. If you have a machine that has this interference problem use the procedures described in this bulletin to correct the problem. (See Figure 1).

If the parts on your unit are damaged, loosen the six bolts that hold the three tubes. Cut the bracket away from the boom. Relocate the bracket on the boom so it clears the frame. Weld in place and paint. Tighten the six bolts. Total time to perform this modification will be approximately 1.5 hours time or less. If parts are required there is a kit that can be installed, the Kit # 02971938.
